Failure report in EP system at KEK/Nomura

SMTF meeting

5 October 2005

Takayuki SAEKI (KEK)

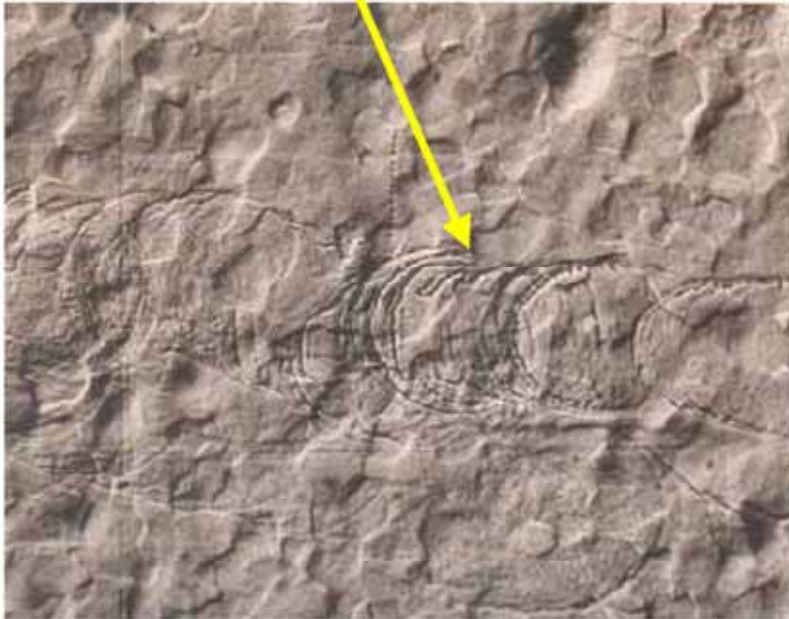
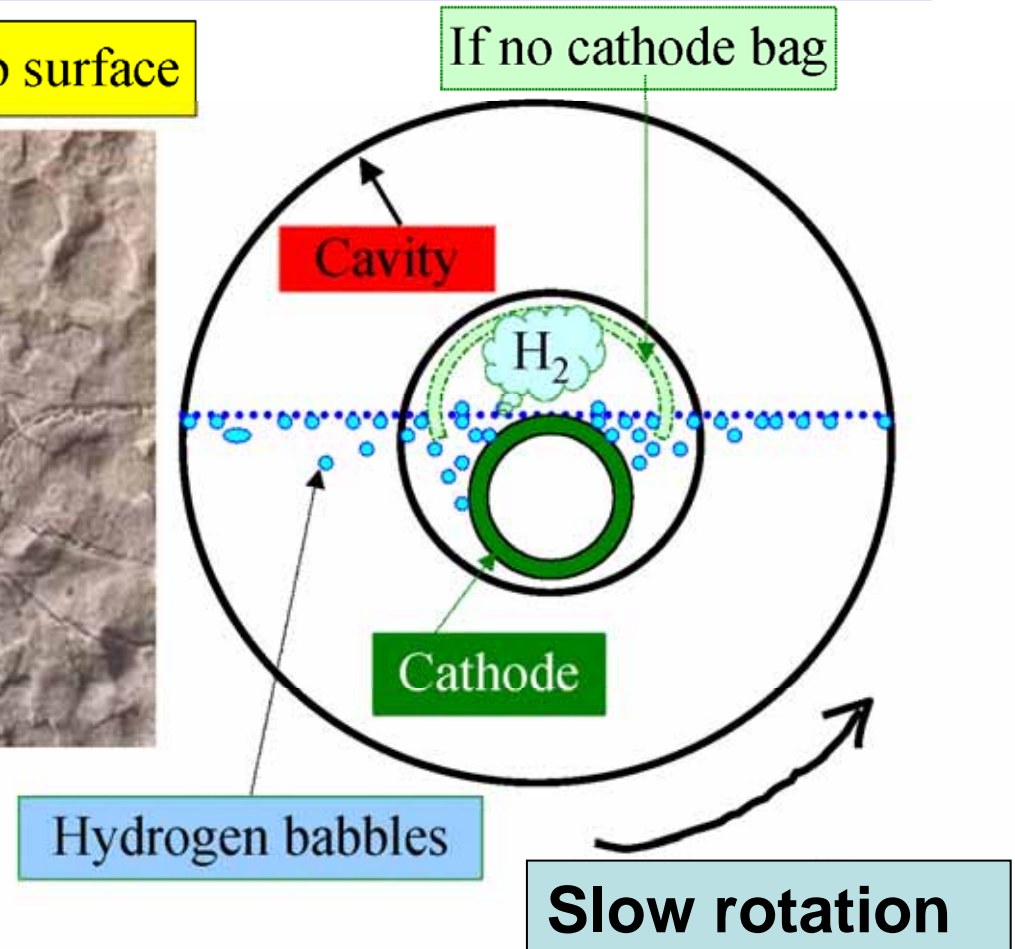
Hydrogen bubble trace on Nb surface

**Cathode bag was not setup properly by operator
=> Hydrogen Q-disease**

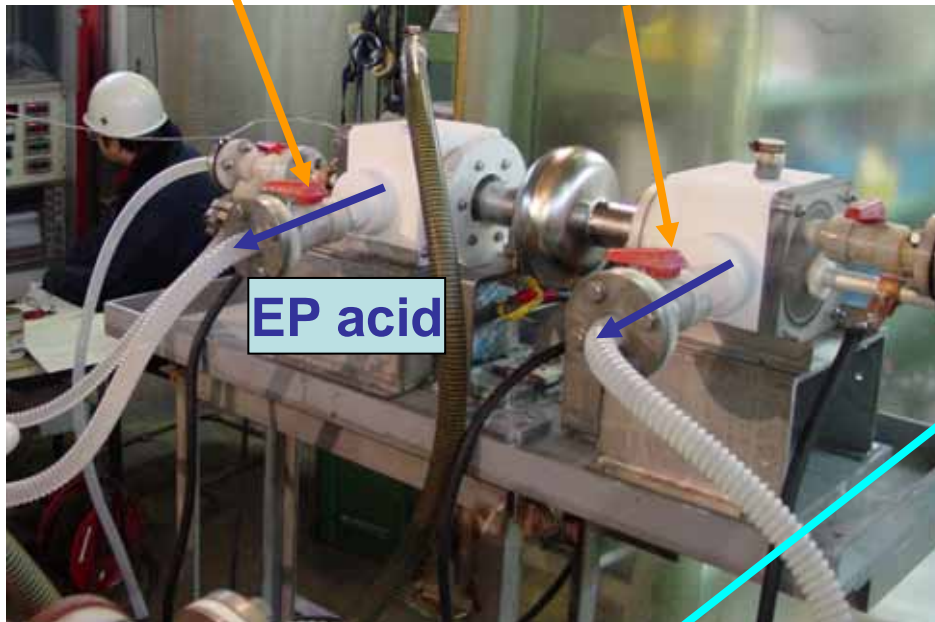
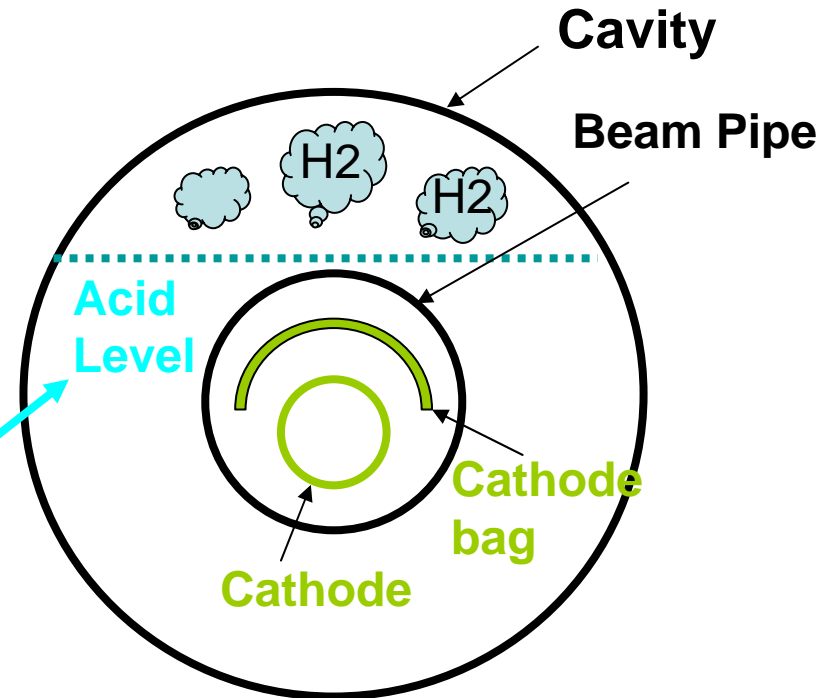
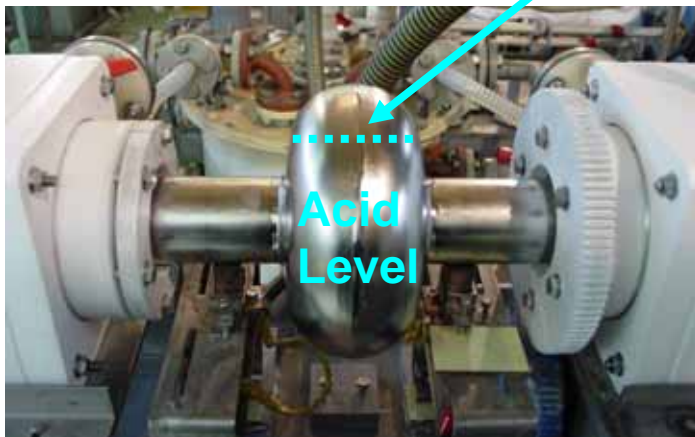
EP acid output valves for level control

EP acid output valve was not properly controlled.

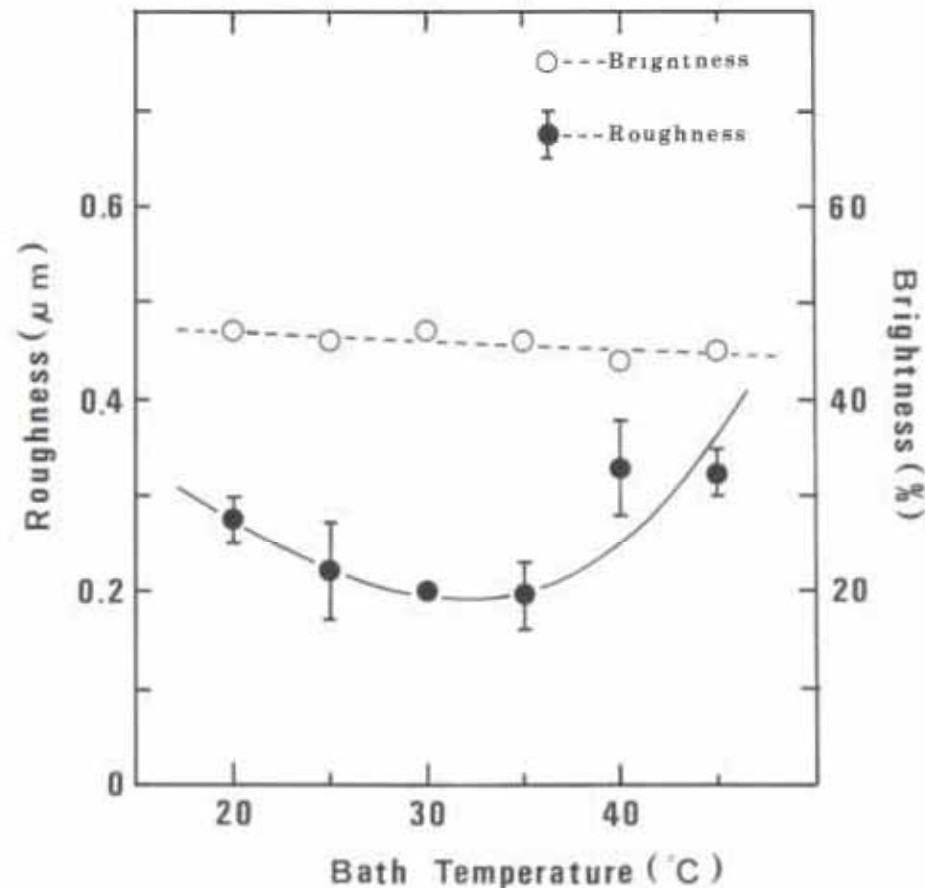
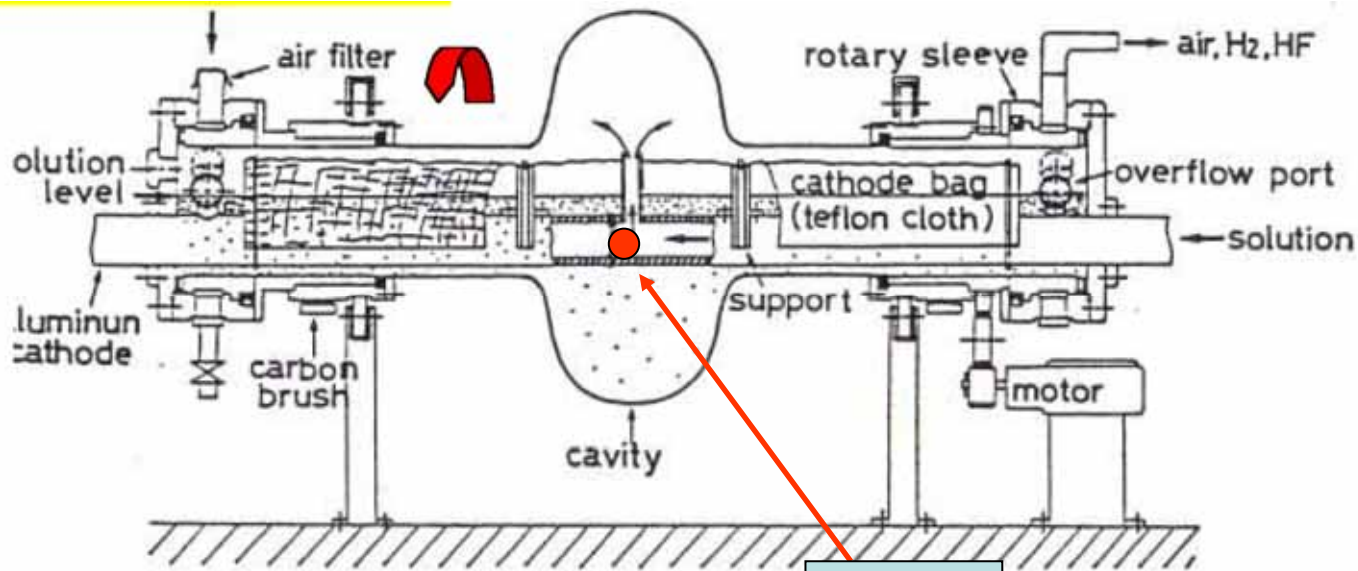
Temperature Effect on EP Finishing

$25 < T < 35^{\circ}C$

$T > 35^{\circ}C$

\Rightarrow also raises the possibility of H Q-disease

**EP acid temperature monitor
& control were not done properly.**

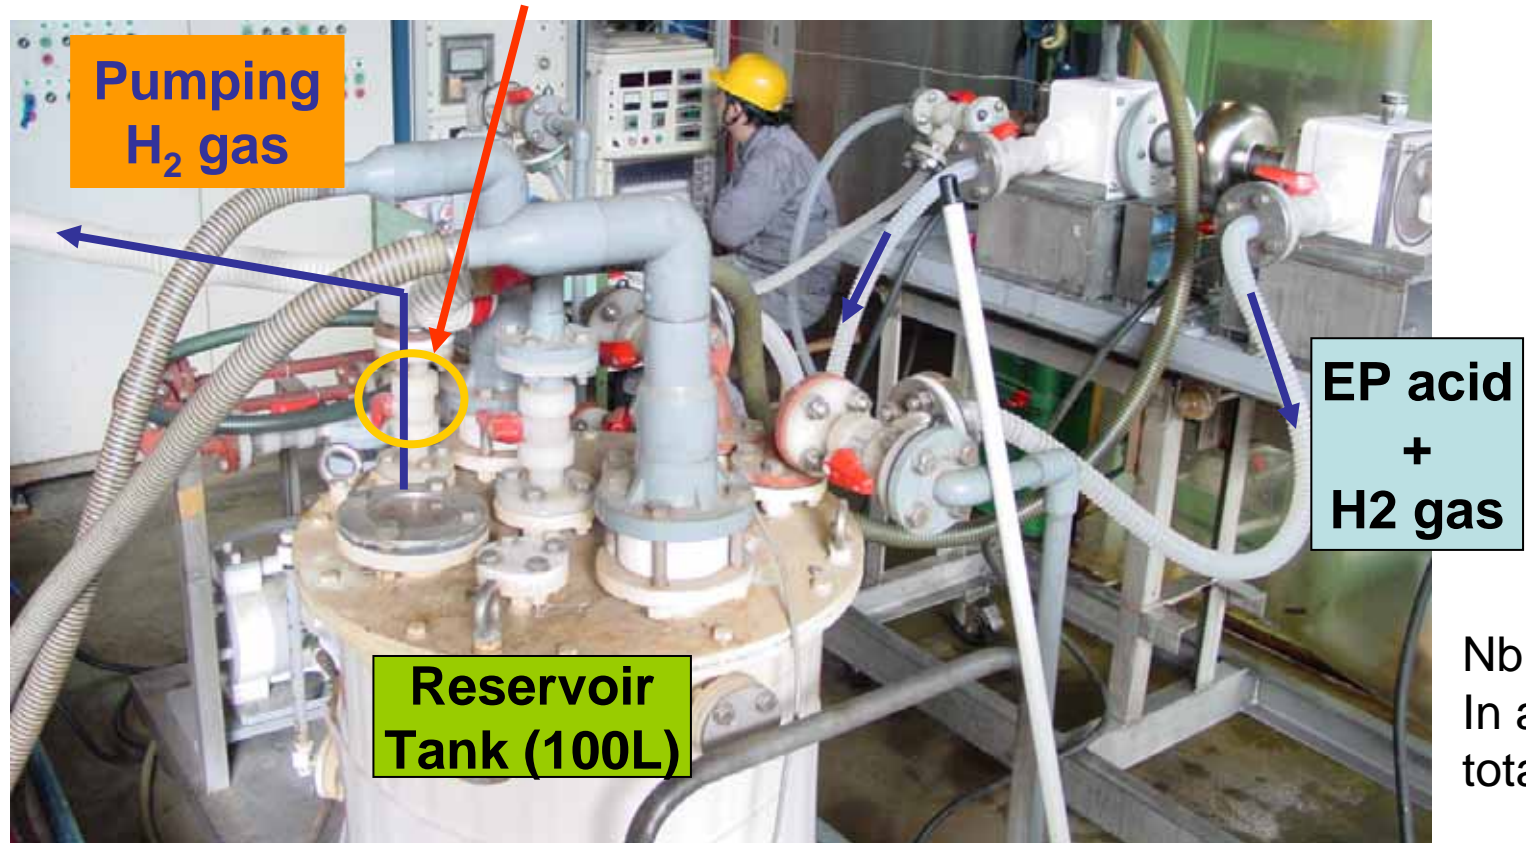
This valve should be open during EP process to pump H₂ gas.
But operator should keep this valve closed after EP process finished. Otherwise, HF escapes from this line.

Operator forgot to close this valve after EP process.

- Operator forgot to close valve.
- HF escaped from the valve and HF density became low in EP acid.

- Needed high-voltage to keep optimum current.
=> High acid temperature.
=> H absorption / surface etching.
=> q-disease / field emission / Q-slope in low field?

EP acid was replaced with new one.

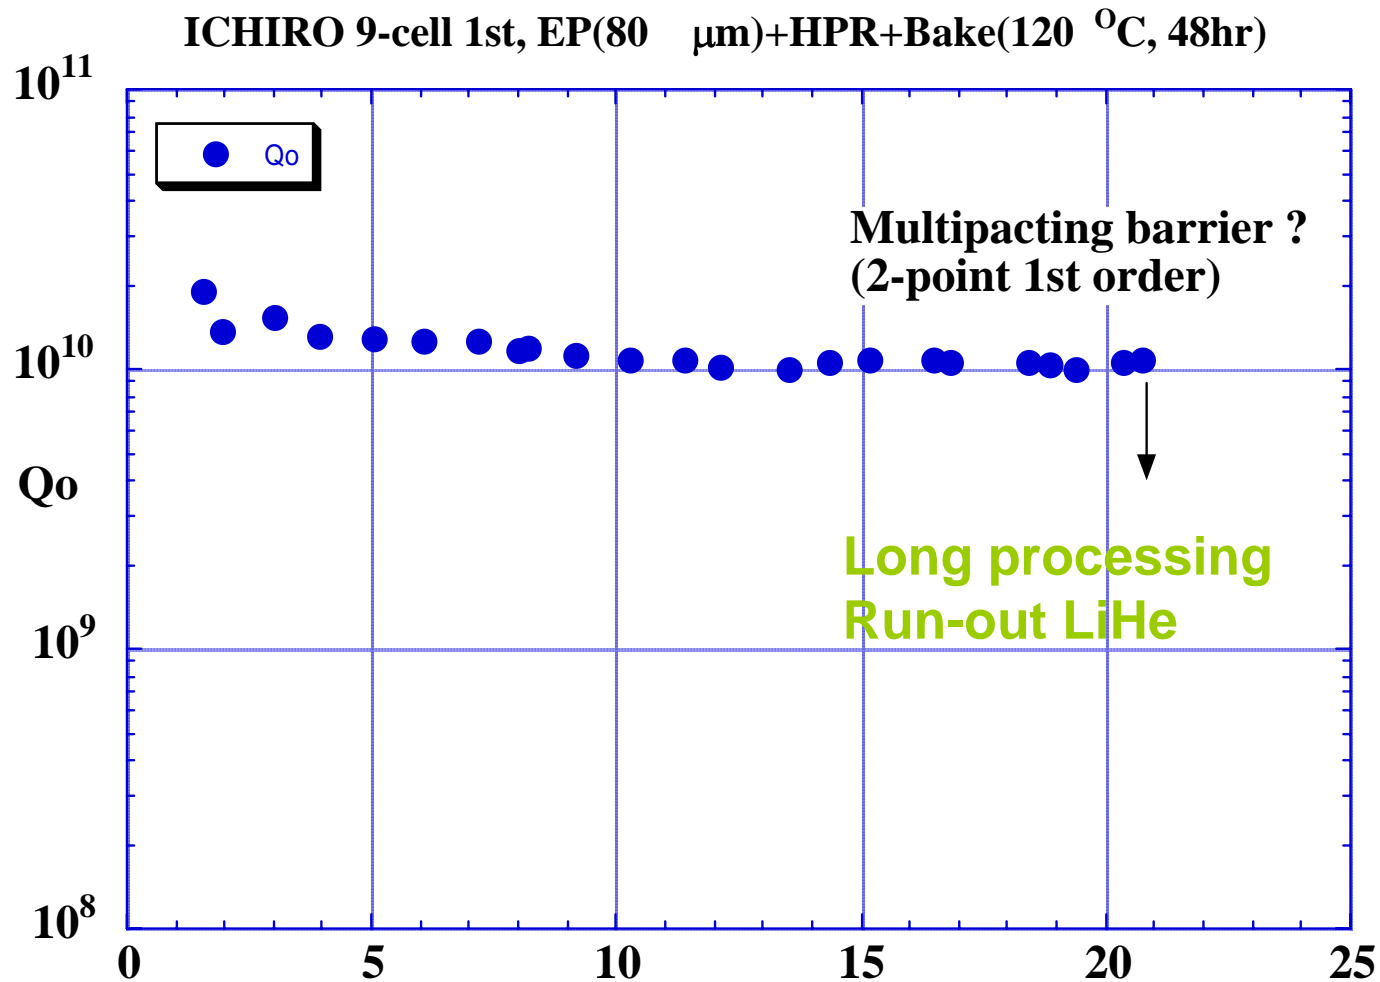
Fig.2: Vertical test result on ICHIRO 9-cell 1st cavity

The lower Q_0 value $\sim 1 \times 10^{10}$ (expected value 2×10^{10}) is due to heating at stainless flanges at both ends.

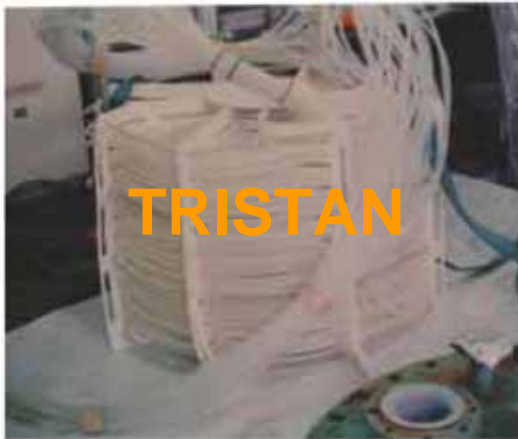
Eduction/deposition
of sulfur around
impure materials
as a core.

After S pollution

Disassembled
EP system and
Cleaned up all parts
by hand.
(TRISTAN)
